## Chapter Three

# ROAD DESCRIPTION, PROBLEM AND OPPORTUNITY ANALYSIS

This chapter gives an overview of the physical, as well as traffic and safety issues associated with the US-41/M-28 corridor. The study area for this Plan extends about  $\frac{3}{4}$  mile either side of US-41/M-28 from the western-most border of Ely Township to the junction of US-41 and M-28 in Chocolay Township, which is about twenty-eight miles in length.

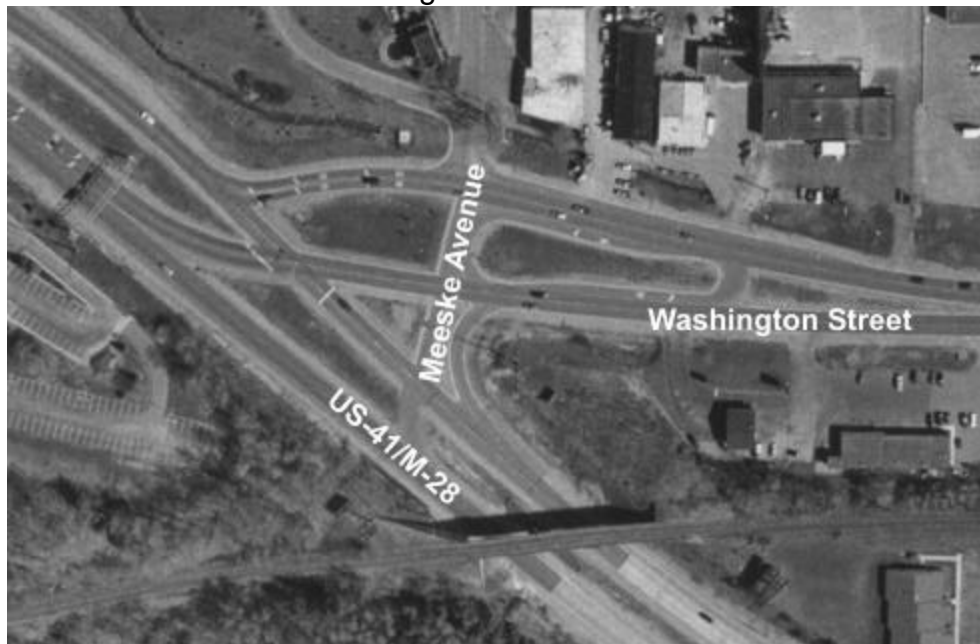
Photo 3-1: Washington Street and US-41/M-28

With 97 crashes over a three-year period, this intersection was the highest within the study area. Over 60 of the crashes were rear-end crashes on westbound Washington Street approaching US-41/M-28. This intersection is confusing especially for drivers not familiar to the area. See Photo 3-1.

The geometry of this intersection is the most complex in the corridor. Both the east and westbound directions of US-41/M-28 are divided roadways. There are four lanes on the eastbound approach, two lanes for left-turns and two lanes for through-traffic. There are two through-lanes on the westbound approach with a right-turn lane under STOP control. The east leg of Washington Street is a divided four-lane roadway. The westbound approach has two lanes that must turn right at US-41/M-28. There is a channelized median left-turn lane for Meeske Avenue. Traffic turning from Meeske Avenue is also allowed to proceed through the intersection to US-41/M-28, under STOP control.

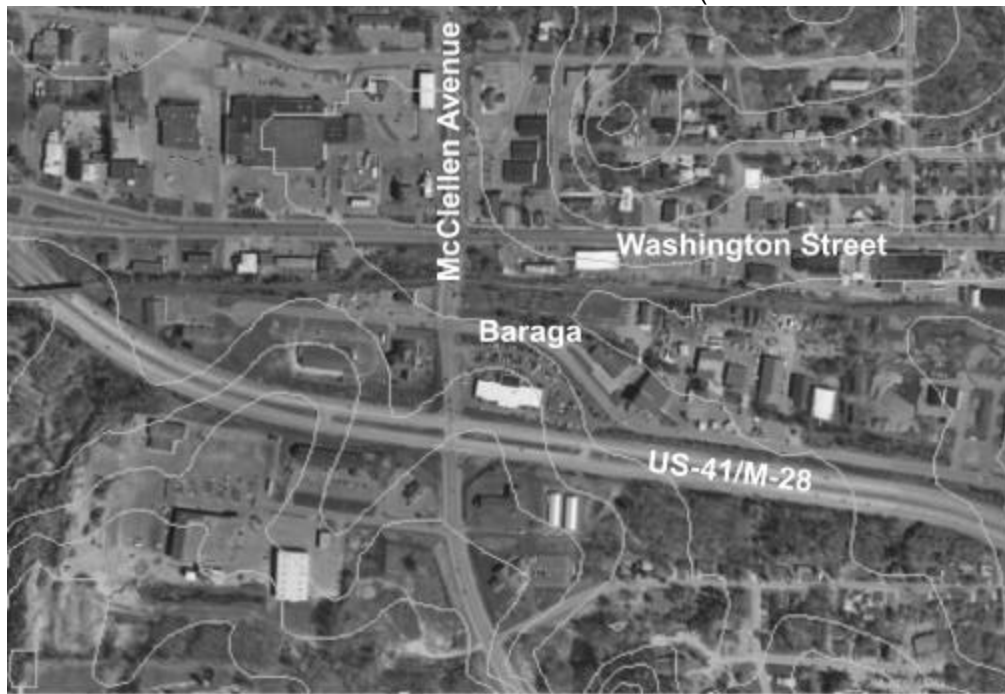
Photo 3-2: McClellan Ave. and US-41/M-28 Intersection (20-foot Contour Lines)

There were 81 crashes at this intersection during the three-year period. The topography at this intersection is of concern. There are steep grades up to the intersection from the north that may cause sight difficulties, particularly in inclement weather. Baraga Avenue, a parallel local street to the north of US-41/M-28, is situated on a slope; it is only about 400 feet away from the US-41/M-28 and McClellan intersection. See Photo 3-2.

McClellan is currently a four-lane road at this point and US-41/M-28 is a divided four-lane highway. Left-turns are prohibited at this intersection and traffic is directed to turn around beyond the intersection at median openings on US-41/M-28.

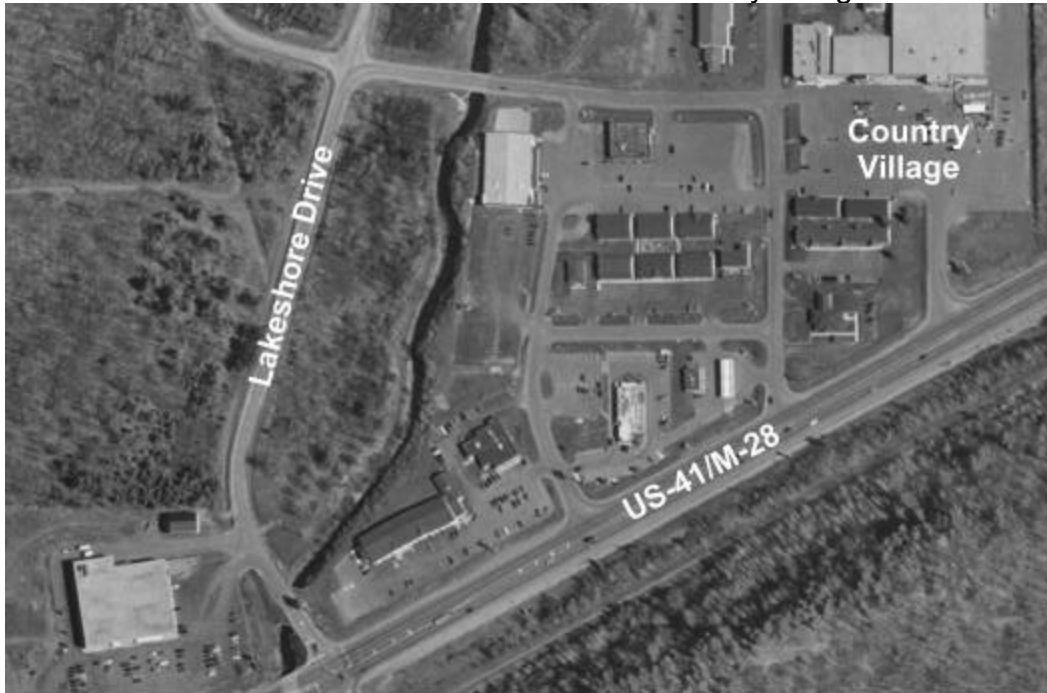
Photo 3-3: Lakeshore Drive and Country Village

This intersection at Lakeshore Drive is located near the western edge of the City of Ishpeming and accommodates traffic from the Country Village shopping center on the northeast corner of the intersection. See Photo 3-3. For the three-year period the intersection had 40 crashes, 21 of which were angle crashes. There was one fatality in this intersection during this time period, the fatality occurred against another driver attempting to make a left-turn from Lakeshore Dr. Eighteen of the 40 crashes involved injuries.

The north and south legs of Lakeshore have two approach lanes including a 100-foot left-turn lane on the north leg and short 60-foot left-turn lane on the south leg. The posted speed on US-41/M-28 is 55 MPH in this area.

The speed limit on Lakeshore Drive is 25 MPH on the north leg and 35 MPH on the south leg. The high speeds in this area may contribute to the higher crash severity. This intersection had the only fatality in the study area during the time period and the highest number of injuries in the corridor study area.

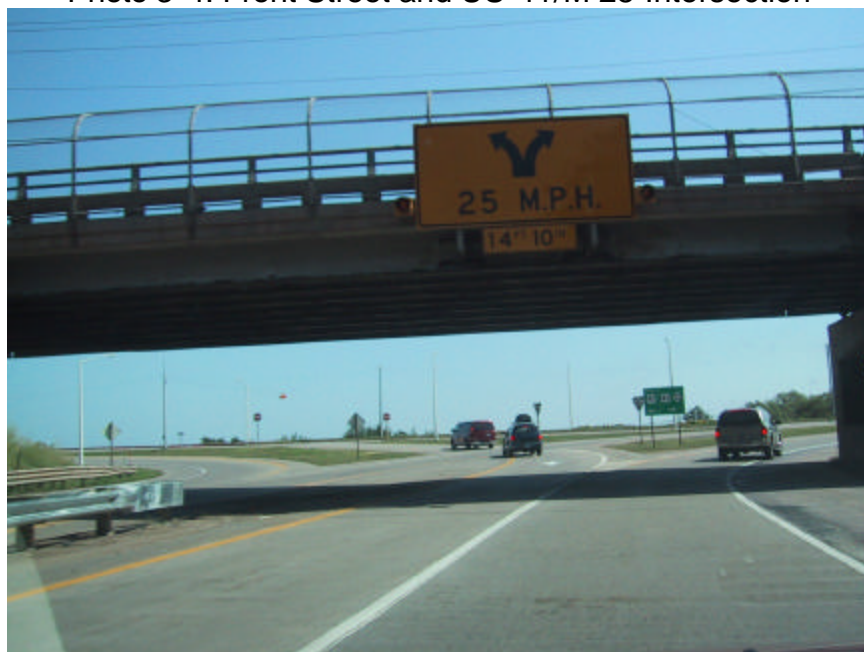
Photo 3-4: Front Street and US-41/M-28 Intersection

The intersection forms a modified “T” with free flowing right-turn movements and channelized left-turn movements. The northbound to westbound left-turn movement must yield to the eastbound to northbound left-turn, even though the traffic volumes are substantially higher. The Champion Street Bridge spans US-41/M-28 on the west side of the intersection. See Photo 3-4.

The northbound approach has two through lanes and a channelized left-turn lane. There is a channelized left-turn merge lane on the north side of the intersection. The southbound approach has two travel lanes. See Photo 3-5. The eastbound approach has two lanes, one for left-turns and one for right-turns. The speed limit on the north and south legs is 35 MPH. The speed limit on the west leg is 55 MPH.

Twenty-two of the 35 crashes at this intersection involve two turning legs of the intersection, the northbound Front Street to westbound US-41/M-28 leg and the eastbound US-41/M-28 to southbound Front Street leg. There were three head on turn collisions in the three year study period. There were 12 rear-end crashes, which occurred in conjunction with turning

movements. The sloping topography and snowy or icy roads contributed to six rollover crashes in this intersection during the study period.

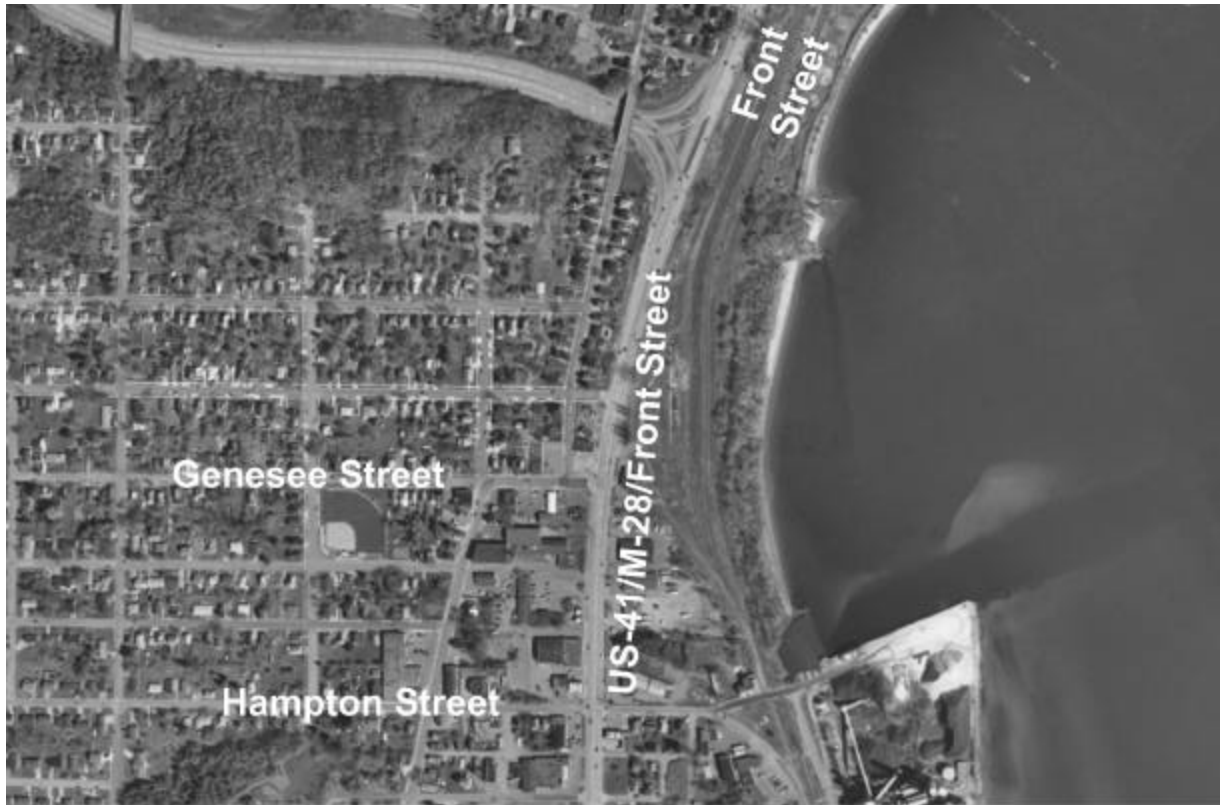
Photo 3-5: Front Street/US-41/M-28

The north and south legs of US-41/M-28 (Front Street) are five-lane roadways with a center lane for left-turn. The intersection forms a "T". The west leg (Genesee Street) has two approach lanes, one lane for left-turns and one for right-turns. The intersection is controlled by a two-phase fixed-time traffic signal. See Photo 3-5.

There are pedestrian indications for crossing the south and west legs. There is a marked pedestrian crosswalk on the south leg that terminates in a flowerbed beyond the east curb line of Front Street. There is no marked pedestrian crosswalk on the west leg.

The South Rail Yard Development is currently under construction along the harbor on the east side of the intersection. The construction driveway is offset approximately 120 feet to the north of Genesee Street. When completed, the access road to the new development will be located at the intersection directly across from Genesee Street. A traffic signal study will soon be conducted to determine whether moving the traffic light from Genesee to Hampton is warranted for either safety or operational reasons.

Twenty-three of the 32 collisions at the intersections were rear-end crashes, nine of these occurred in the southbound Front Street approach and nine on the northbound Front Street approach. Approximately 36% of the rear-end crashes occurred on wet/snowy/icy pavement.

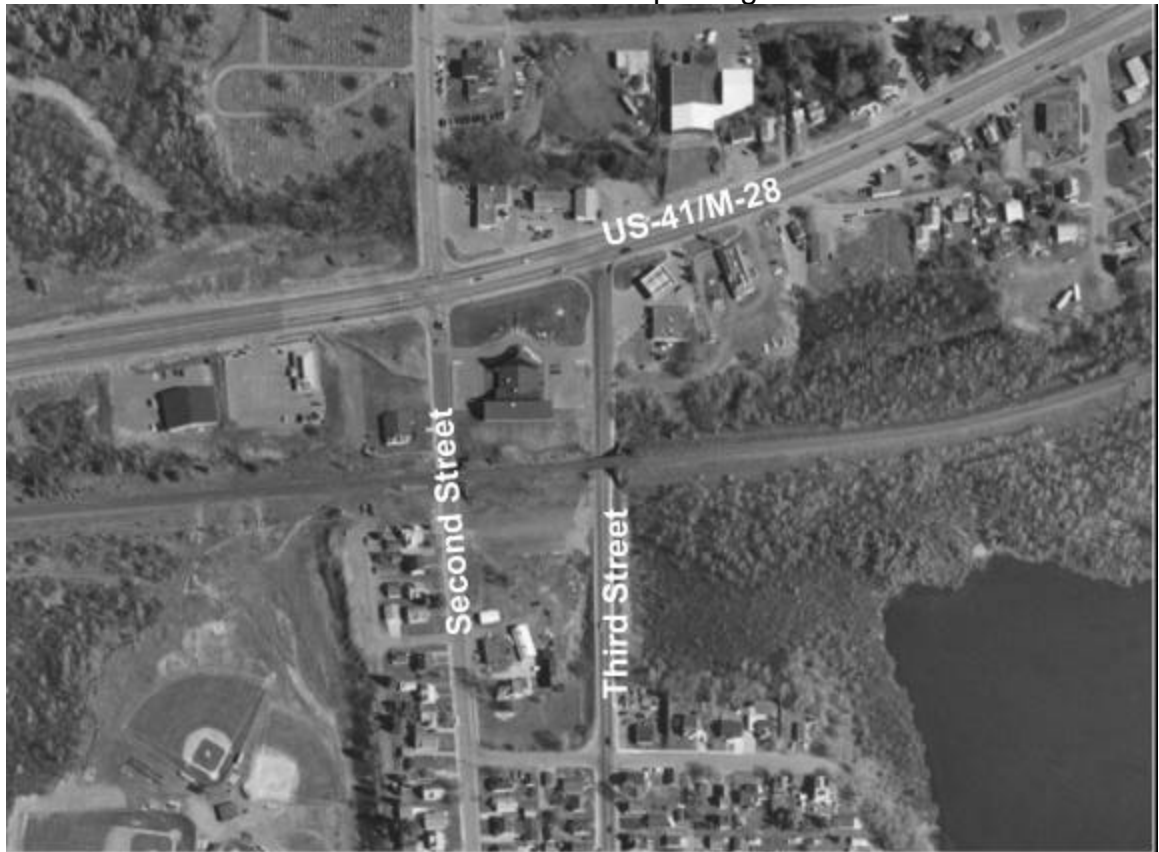
Photo 3-6: Second Street in Ishpeming

The east leg of US-41/M-28 is a five-lane roadway with center lane for left-turn. The west leg of US-41/M-28 is five-lanes with a marked 125-foot long left-turn pocket marked at the intersection. The north and south legs of Second Street has two approach lanes, including a short 90-foot long left-turn lane on the north leg and a 70-foot long left-turn lane on the south leg. See Photo 3-6. The posted speed limit on US-41/M-28 is 45 MPH. The speed limit transitions to 55 MPH west of the intersection. The speed limit on Second Street is 25 MPH.

The intersection is controlled by a two-phase fixed-time traffic signal. There are no pedestrian indications and no marked pedestrian crosswalks. There were twelve rear-end crashes and seven head-on left-turn crashes out of 30 total crashes within the intersection. Eleven of the crashes resulted in injuries.

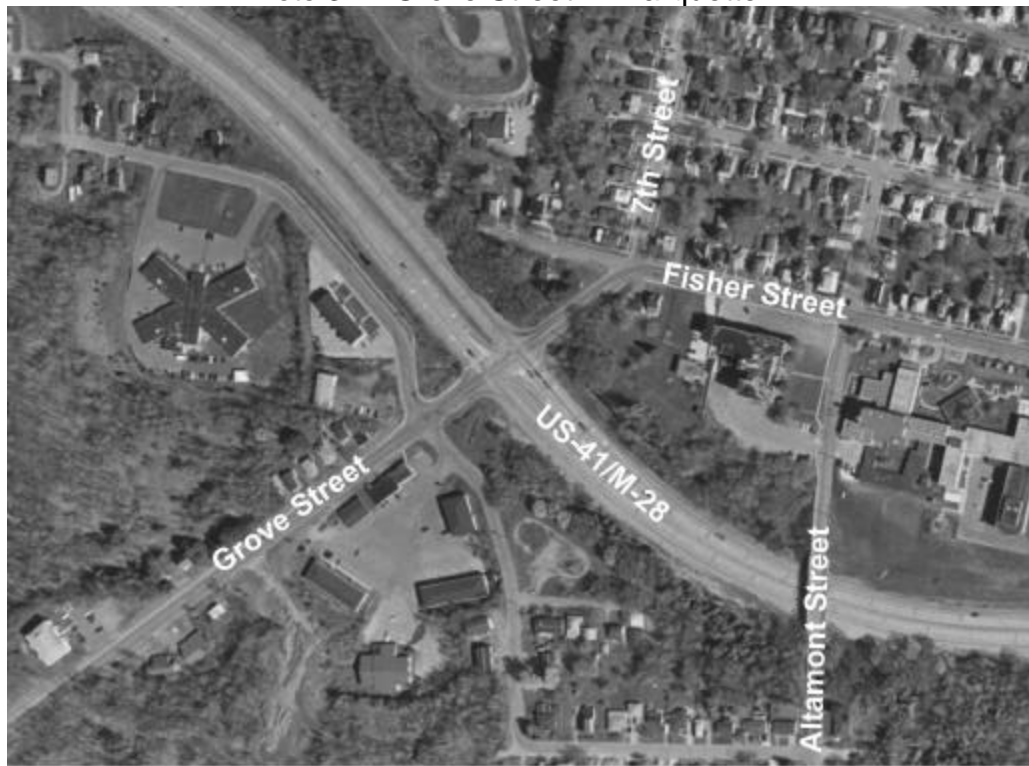
Photo 3-7: Grove Street in Marquette

The east and west legs of US-41/M-28 are divided four-lane roadways with a channelized left-turn lane at the intersection. There are two approach lanes on the north and south legs of Grove Street, one lane for through traffic and one lane for right-turns.

Left-turns are allowed in all directions at the intersection because the median does not have sufficient width to provide median crossovers beyond the intersection to accommodate indirect left-turns. See Photo 3-7. There is a leading protected left-turn phase on US-41/M-28. Left-turns are not permitted during the through phase. The posted speed limit on US-41/M-28 is 55 MPH. The posted speed limit on south leg of Grove Street is 25 MPH. There are no pedestrian indications or marked crosswalks.

There were 23 crashes at this intersection during the study period. Fifteen of the crashes were rear-end crashes.

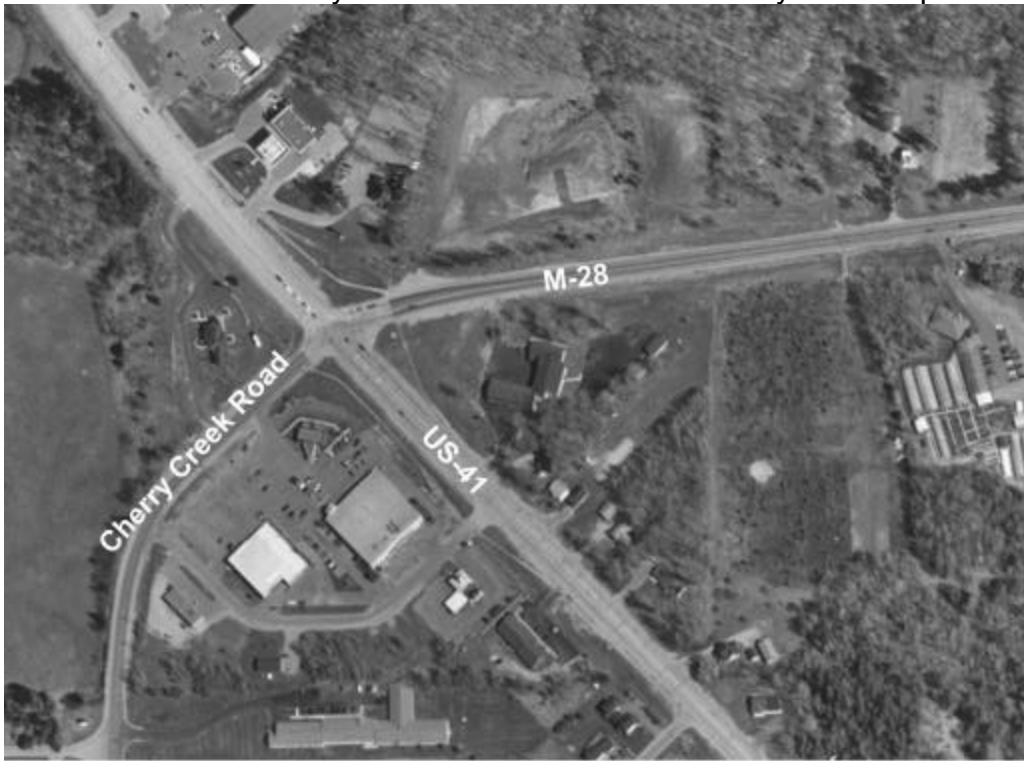
Photo 3-8: Cherry Creek Intersection in Chocoday Township

8. US-41/M-28 at M-28 Junction and Cherry Creek Rd (in Chocoday Twp.)  
US-41 (south leg) and M-28 (east leg) merge at this location. The north leg (combined US-41 and M-28) and the south leg of the intersection are five-lane roadways with center lane for left-turn. US-41/M-28 transitions to a two-lane roadway south of the intersection. The east leg (M-28) has a short 100-foot long right-turn lane marked at the intersection with a long taper.

The west leg (Cherry Creek Road) has three lanes at the intersection including a 150-foot long left-turn lane. Cherry Creek Road transitions to a two-lane roadway west of the intersection. See Photo 3-8. The posted speed limits are 45 MPH on the north leg, 55 MPH on the south leg, 45 MPH on the west leg, and 55 MPH on the east leg. There are no pedestrian indications or crosswalks at the intersection.

Observations reveal that the major turning movements at the intersection are the southbound to eastbound left-turn and the complementary westbound to northbound right-turn. Conversely the northbound to westbound left-turn volume is relatively light. Therefore the southbound through-right signal phase often operates simultaneously with the southbound left-turn phase. Of the 23 crashes at the intersection, 9 were southbound to eastbound left-turn collisions.

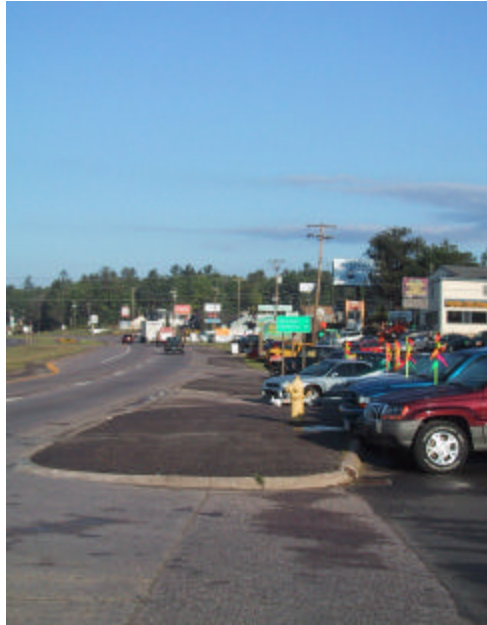
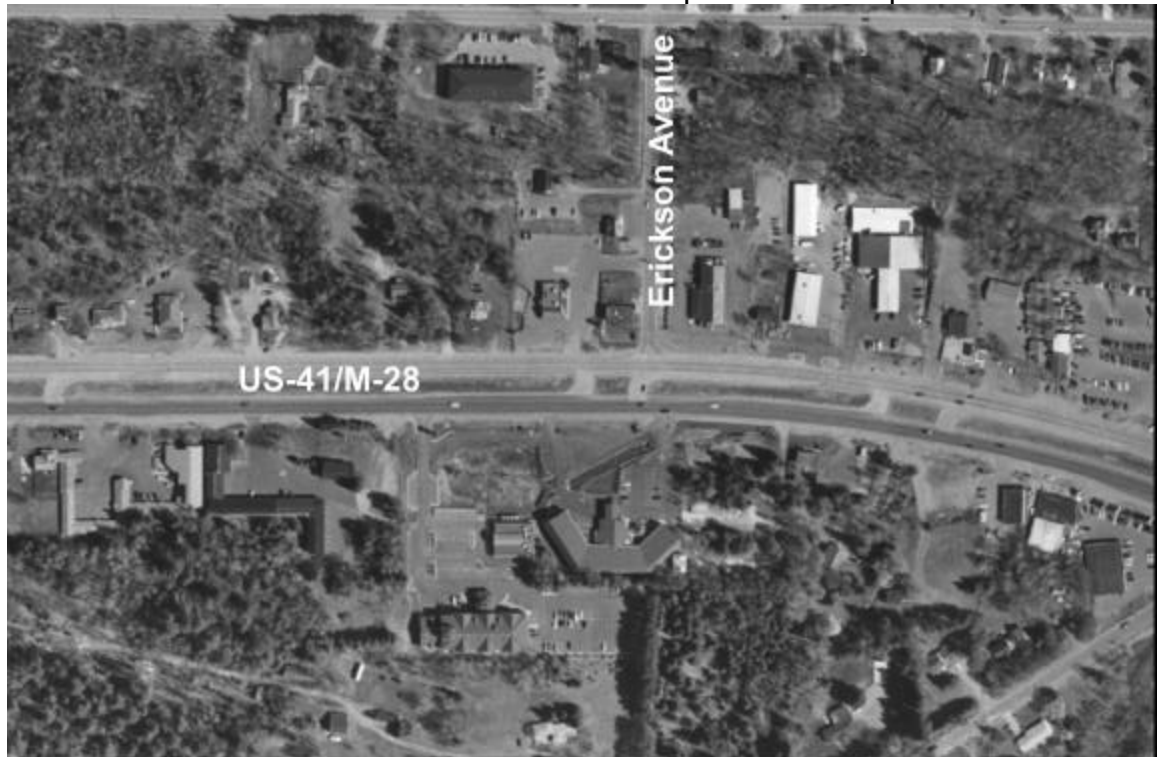
Crash data at this site included only 2001 and 2002. This is a mid-block location where Erickson Avenue forms a "T" intersection with US-41/M-28. A directional crossover is located directly across from Erickson Avenue for eastbound traffic. Erickson Avenue is controlled by a STOP sign.

Photo 3-9: Numerous Driveways

Twenty-three crashes occurred at this intersection in the last two years (2001-2002). Half of the crashes were angle collisions, attempting a left-turn via the media opening. Thirteen of the crashes were on wet/snowy pavement. There is notable problem with driveway related crashes due to the numerous driveways and signs along this part of the corridor. See Photo 3-9 and 3-10.

Photo 3-10: Erickson Avenue in Marquette Township

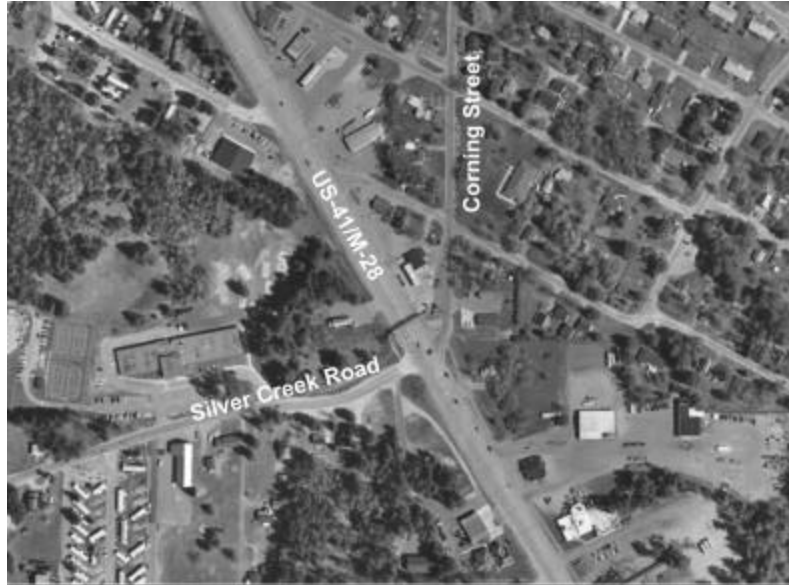
Photo 3-11: Silver Creek Road Intersection with US-41/M-28

The north and south legs of US-41/M-28 are five-lane roadways with a center lane for left-turns. The eastern leg of the intersection is Corning Street, while on the west the street is called Silver Creek Road. The access drive to the Township offices is only 75 feet from the intersection on Silver Creek Road. See Photo 3-11.

Eight of the 21 crashes were southbound rear-ends. The visibility of the southbound US-41/M-28 traffic signal may be a problem for drivers of trucks and busses because of the pedestrian bridge located on the north side of the intersection. There were five angle and four head-on left-turn crashes.

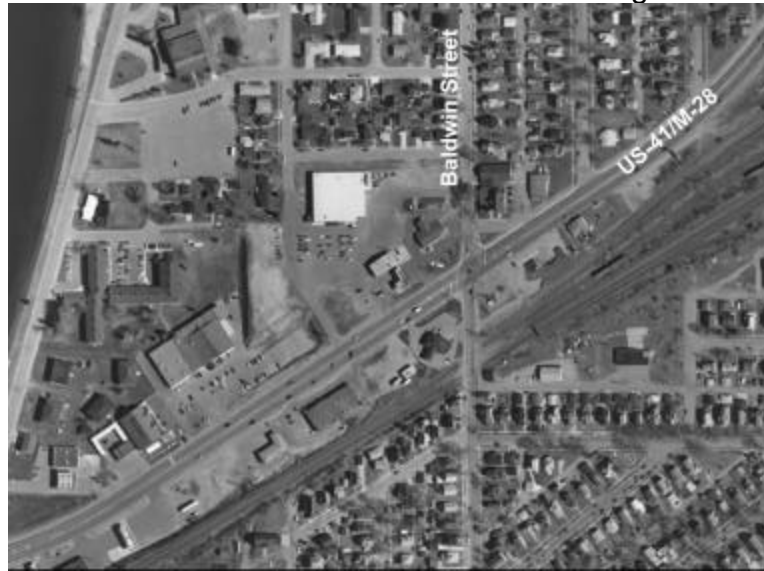
Photo 3-12: Baldwin Street intersection in Negaunee

The east and west legs of US-41/M-28 are five-lane roadways with center lane for left-turn. The north and south legs of Baldwin Avenue has two approach lanes, including a short 80-foot long left-turn lane on the north leg and a 100-foot long left-turn lane on the south leg. See Photo 3-12. The posted speed limit on US-41/M-28 is 45 MPH. The speed limit on the Baldwin Avenue is 25 MPH.

There are pedestrian signal indications on all four legs of the intersection. There are marked pedestrian crosswalks on the east and west legs only. Thirteen of the crashes were angle collisions.

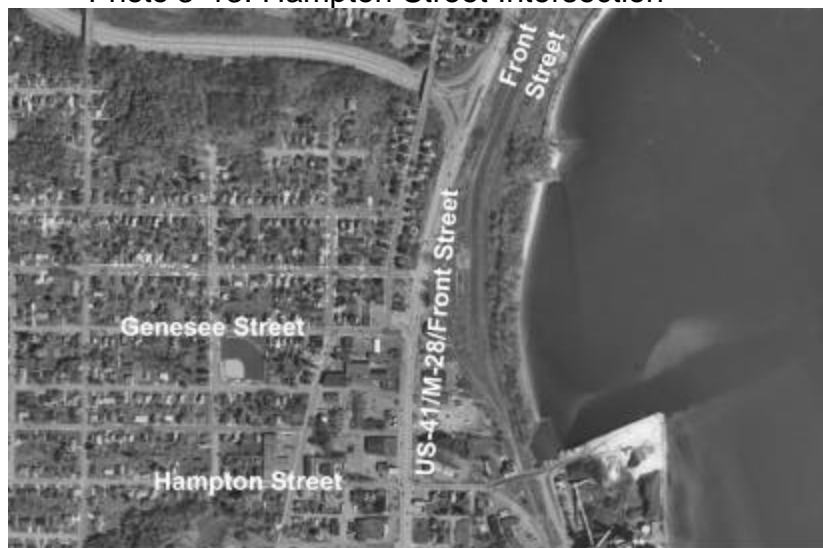
Photo 3-13: Hampton Street Intersection

This intersection is approximately 400 feet south of the Genesee Street signal. Hampton Street is controlled by STOP signs in both legs. US-41/M-28 operation is similar to the Genesee Street description, except the north bound US-41/M-28 speed changes from 50 MPH to 35 MPH at Furnace Street (one block south of Hampton Street). See Photo 3-13.

The crash pattern is similar to Genesee Street except this intersection is NOT signalized. It is notable that four collisions occurred at the multiple driveways of a tire center. As noted with the Genesee Street analysis, a traffic signal analysis will be performed to determine whether to change the signal location from Genesee Street to Hampton Street.

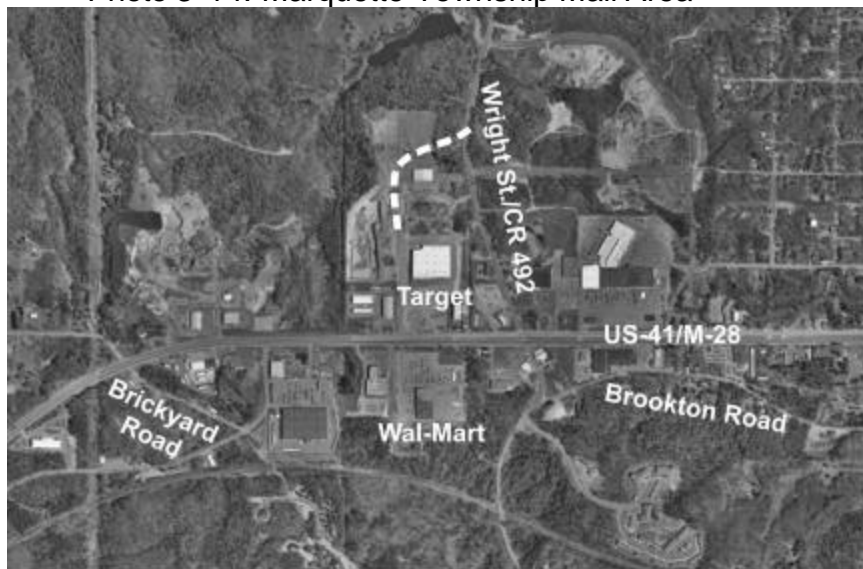
Photo 3-14: Marquette Township Mall Area

Crash data at this site included only 2001 and 2002. The intersection of US-41/M-28 and County Road 492 (Wright Street) is controlled by STOP signs on County Road 492. There is a median cross-over on eastbound US-41/M-28 to service the left-turn movement from eastbound to northbound. Therefore, all traffic on the northbound and southbound approaches on 492 must turn right at the intersection. Northbound and southbound straight-thru traffic on County Road 492 is not permitted at the intersection. See Photo 3-14. Northbound approach traffic with travel destination to the north or west is supposed to use the median cross-over located 1,200 feet to the east of the intersection (i.e. at the Westwood Mall entrance). However, local sources indicate that it is fairly common for northbound traffic from CR 492 intending to continue northbound or westbound on US-41, to ignore the "Do Not Enter" sign. There is no physical barrier such as curbing to stop this movement. Similarly, southbound approach traffic with travel destination to the south or east must use the median crossover located 1,300 feet to the west of the intersection. Therefore the total adverse travel for each indirect movement is nearly one-half mile distance.

The southbound County Road 492 approach is marked as two lanes. However, southbound traffic queues in the right lane only and does not utilize the second (left) lane. The lane separation is confusing.

There are right-turn lanes on both the eastbound and westbound US-41/M-28 approaches to the intersection. The posted speed limit on Wright Road is 45 MPH. Analysis of the two-year crash data indicates mostly rear-end collisions. The geometrics of median crossover are substandard.

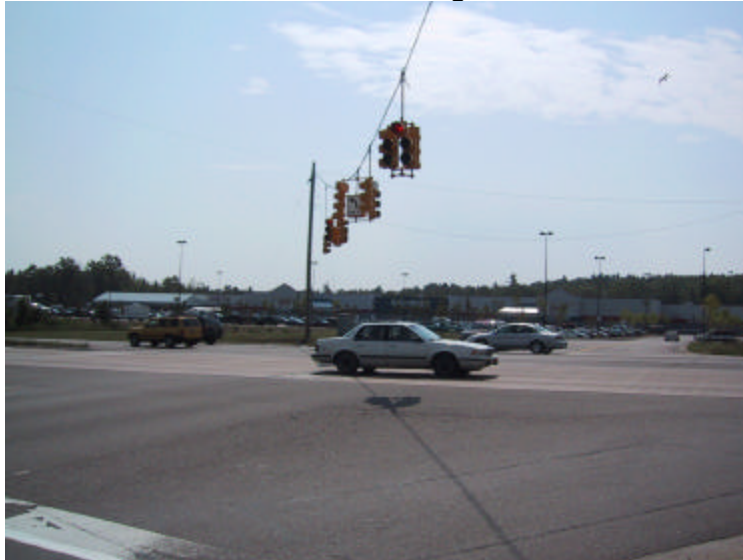
Photo 3-15: Wal-Mart/Target Intersection

The intersection of US-41/M-28 and the Target Drive-Wal-Mart driveway serves as the primary access points to the Wal-Mart store located on the south side of US-41/M-28 and the Target store located on the north side. To date, there is not a high level of crashes at this intersection. The signal operates with separate left-turn phases for traffic on the eastbound and westbound approaches on US-41/M-28 (see Photo 3-15).

The westbound US-41/M-28 approach to the intersection has four lanes; one lane for left-turns, two lanes for thru traffic, and one lane for right-turns. The eastbound approach has three lanes including one lane for left-turns. Both the northbound and southbound approaches to the intersection have three lanes; one lane for left-turns, one lane for thru traffic, and one lane for right-turns. The speed limit on US-41/M-28 transitions to 55 MPH west of the intersection.

Once the connector from Wright Street/CR 492 to Target Drive is constructed, much of the traffic turning westbound on US-41/M-28 at Wright Street will divert to Target Drive and this intersection will become much busier (while that at Wright Street/CR 492 will go down).

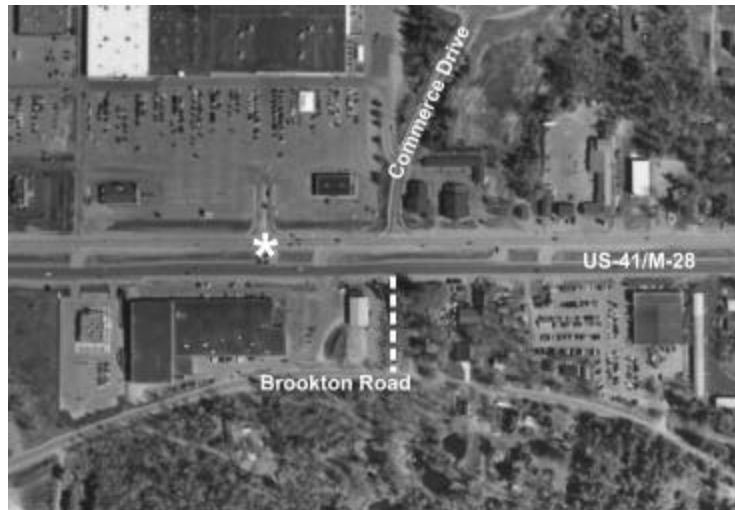
Photo 3-16: Westwood Mall Traffic Signal (\*) and Commerce Drive

The intersection of US-41/M-28 and the median crossover at the Westwood Mall (Kohl's) entrance-exit driveway is controlled by a traffic signal. The signal operates on an 80 second background cycle to maintain coordination with the traffic signal at Target Drive-Wal-Mart. The median crossover on US-41/M-28 services the left-turn movement from eastbound US-41/M-28 into the mall

entrance. The median crossover also services the U-turn maneuver from eastbound US-41/M-28 to westbound. However, it is confusing to know who has the right-of-way; those making the U-turn or those exiting the mall. See Photo 3-14 and 3-16.

There is a right-turn lane on westbound US-41/M-28 at the intersection. All traffic exiting the mall must turn right. The mall driveway is divided by a center median. The twenty-two foot wide southbound mall exit operates as two approach lanes to the intersection.

The driveway at Applebee's west of the mall entrance is right in front of a median crossover permitting westbound traffic to complete a U-turn. Traffic conflicts are created by the combination of the driveway and the crossover location which could be resolved by relocating the crossover east of its present location. See further discussion in Chapter Four.

Currently there are median crossovers on US-41/M-28 to the east and west of Commerce Drive. See Photo 3-16. If the signal were moved to Commerce Drive, a decision must be made as to whether left-turns would be permitted or directed to the median crossovers. The median left-turn lanes are currently formed opposite Commerce Drive. The location of the existing median crossovers does not meet the MDOT standard of placing crossovers 600 feet distant from a signalized intersection.
